# Diamond Tools—An Engineers Best Friend

By George Seegebrecht, P.E.

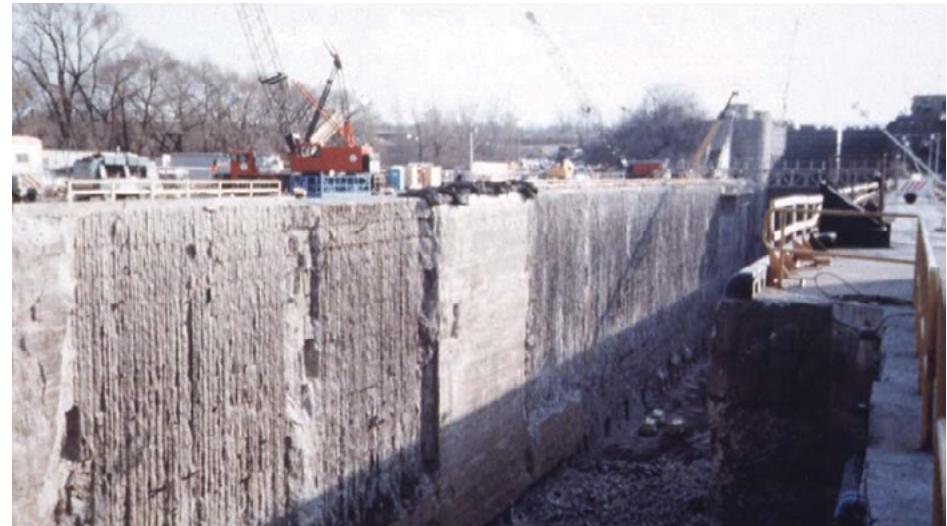
Fig. 1 Close-line drilling along with explosive charges in alternating drill holes was used to remove deteriorated lock walls during rehabilitation.

The faces of deteriorated lock walls that provided over 60 years of service were removed to a depth where sound concrete was encountered (Figure 1). The wall faces were then recast with a high-quality concrete to re-establish original dimensions. Close-line drilling of approximately 2-inch diameter by 60-feet deep were drilled approximately three feet behind the existing lock wall face. Holes were alternately filled with explosive charges to quickly facilitate removal of the wall face.

Holes had to be plumb and equidistant to efficiently transmit the blasting energy

between holes to ‘unzip’ the wall face upon controlled detonation. Poor drilling that resulted in greater distances between drill holes or holes that wandered too far or near to the wall face could have resulted in inefficient concrete removal. This could have increased the need for follow-up demolition methods that may have significantly slowed project progress, increased costs and created safety issues. The expertise of the drilling contractor and their drilling consistency was a vital component of the successful, efficient and safe removal of the deteriorated concrete. Drilling is probably not what most think of about similar locks, but it’s a precision method of concrete modification that led to the success of this project. Most CSDA contractors would be able to perform this type of drilling.

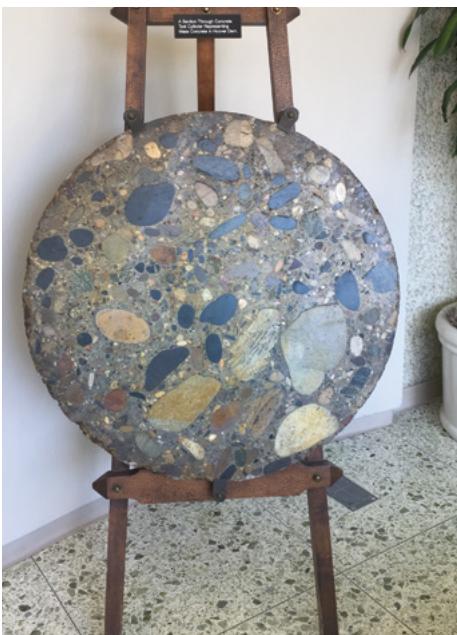
*Fig. 2 Concrete core taken from the Hoover Dam constructed between 1931 and 1936.*

A residual benefit of this test specimen occurred when the Bureau of Reclamation gifted a trimmed section of one of these large cores to the Portland Cement Association (PCA). A slice from a three foot diameter core is exhibited in the PCA lobby in Skokie, Illinois (Figure 2).

Note the large aggregate (over nine inches top size) seen almost exclusively on such massive concrete structures. The larger aggregate size meant less cement was needed in the mix. A lower cement content (less expensive) led to a more economical concrete. Larger aggregate and less cement translate to less total water per cubic yard. Keeping a constant water-to-cement ratio means less water is needed in the mix translating to relatively smaller drying shrinkage and a corresponding reduction in concrete cracking. A lower cement content also means a reduction in the peak heat of hydration, an important consideration to minimize thermal related cracking when constructing a structure as massive as the Hoover Dam.

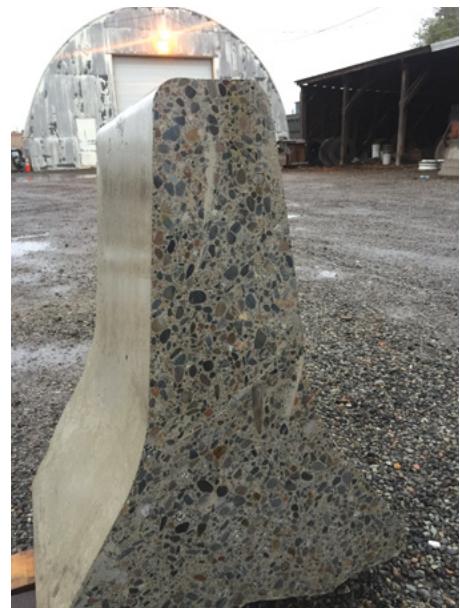
*Fig.3a Traffic barrier saw cut to provide visual examination of its cross-section.*

However, when performance is not as expected everyone has questions. Examining the construction of typical specimens is helpful. Figures 3a and 3b show dissected barriers to examine if the fabrication procedures of the barrier were deficient.

The randomly selected sample shown in Figure 3a was dissected for examination. The samples exhibited nearly defect-free formed surfaces. Looking beyond the surface, saw cutting revealed the concrete mix was thoroughly consolidated. The examined cut surface indicated uniform aggregate distribution and complete encapsulation of the reinforcing bars.

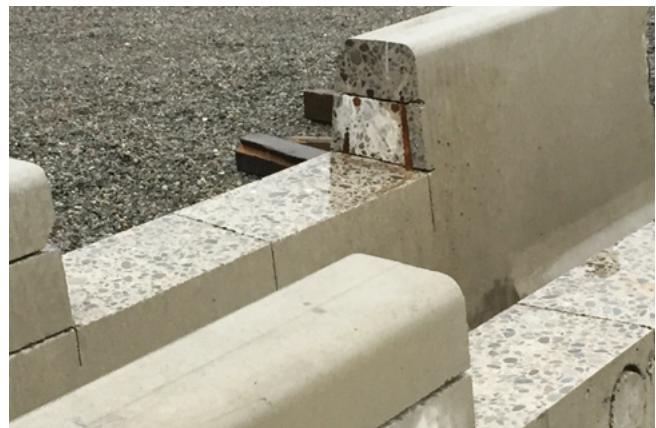
*Fig. 3b Slices through traffic barrier exhibit uniform aggregate distribution and good consolidation around reinforcing steel maintaining proper concrete cover.*

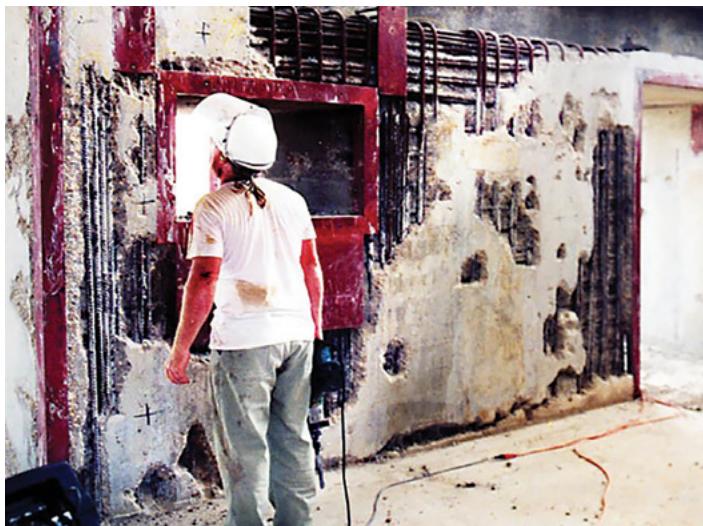
*Fig. 4 Difficult conditions for concrete placement within forms and deficient consolidation in highly congested foundation.*

Figure 4 shows one example of congested reinforcement, where restricted concrete placement and consolidation resulted in voided and honeycombed concrete.

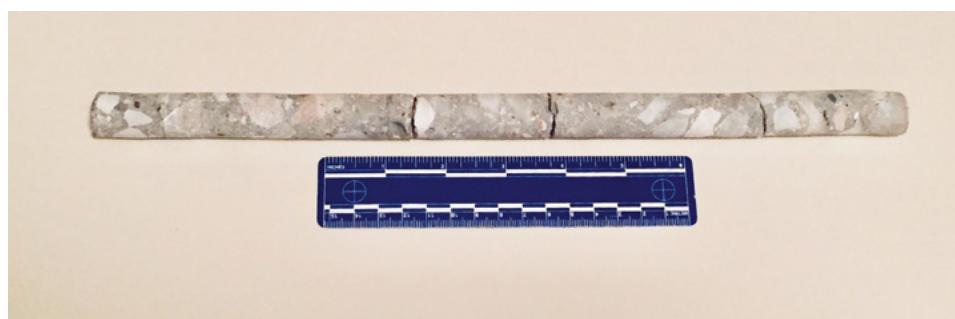
*Fig. 5. Half inch diameter probes used to assess integrity of interior concrete in congested members.*

Other NDT methods can be considered as listed in ACI 228, but a rough first look at the condition of the interior could be the drilling of small diameter holes that avoid reinforcing

steel and give at least a qualitative look at the concrete intercepted in that probe hole. Closer inspection of the core hole with fiber optic can provide information on the condition of questionable concrete.
